# INDIAN ISLAND FLEET MOORINGS UNDERWATER INSPECTION REPORT

APRIL 1983

OCEAN ENGINEERING  
AND CONSTRUCTION PROJECT OFFICE  
CHESAPEAKE DIVISION  
NAVAL FACILITIES ENGINEERING COMMAND  
WASHINGTON, D.C. 20374

FPO-1-83 (2)

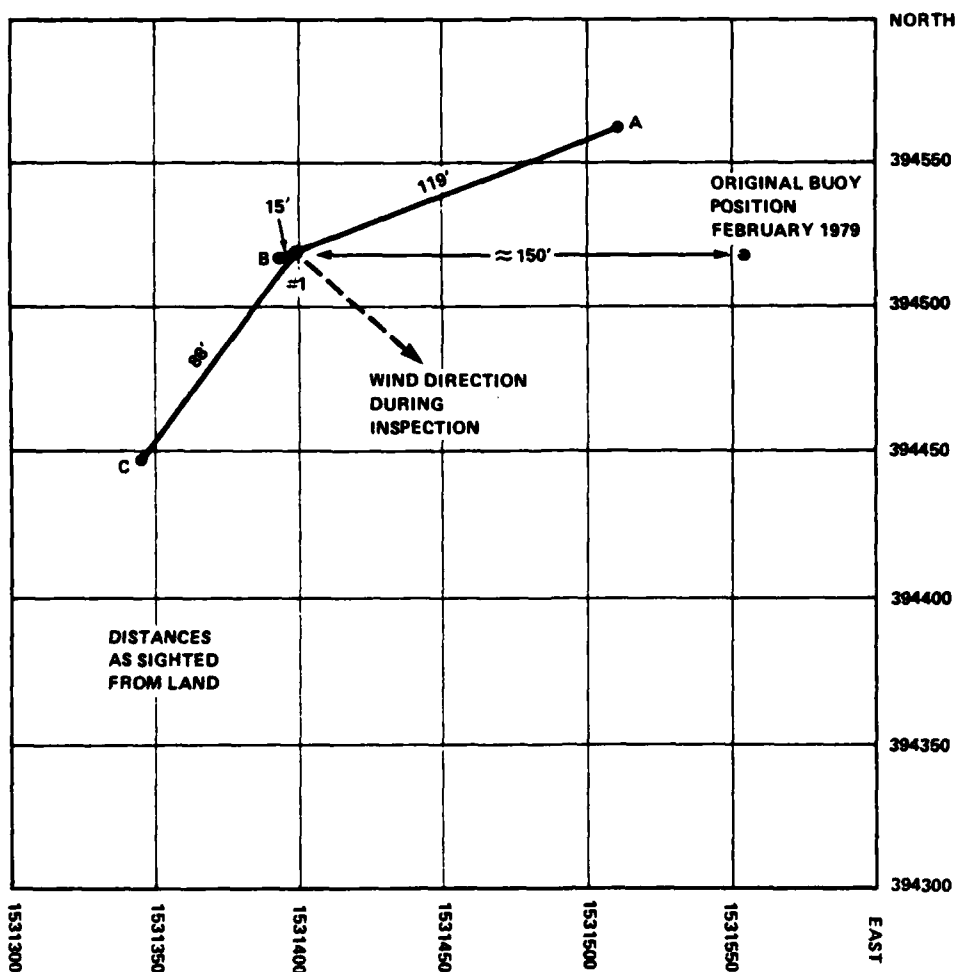
MOORING #1  
CONFIGURATION

The results of this inspection revealed one major deficiency: Mooring number 1 has moved from its desired location. Recommend the cause of the failure be investigated and the mooring be redesigned and reinstalled. Comments concerning the specific condition of each of the moorings are included.

This is a 12' diameter Mark II Peg Top type buoy. Some light to moderate rusting is evident, and the buoy's lower hull is covered with a heavy marine growth. The buoy has two wooden fenders and a chafing rail, all in good condition. The buoy's top and bottom connecting hardware appear to be in good condition. The position of the buoy is currently about 150' west of its installed position.

The three ground legs, as initially installed, are comprised of 2 1/4" chain. Each of these legs enters the mud at a depth of about 100'. Double link measurements of each leg were taken just below the ground ring, at the wear point (mud line), and halfway in between the two. Measurements were all greater than 90 percent of original wire diameter. Measurements of the catenary angles at three depths of each leg were taken, and the results are noted on the following diver report sheet. Leg B was observed to run vertically from the ground ring to the bottom.

The mooring chain is in satisfactory condition for continued use in its currently rated and tested capacity as a modified Class E mooring. However, the buoy's current position indicates a significant displacement of the ground legs and anchors. Recommend the forces on the buoy be reevaluated with the possibility of a redesign and repositioning of the mooring back to its original position.

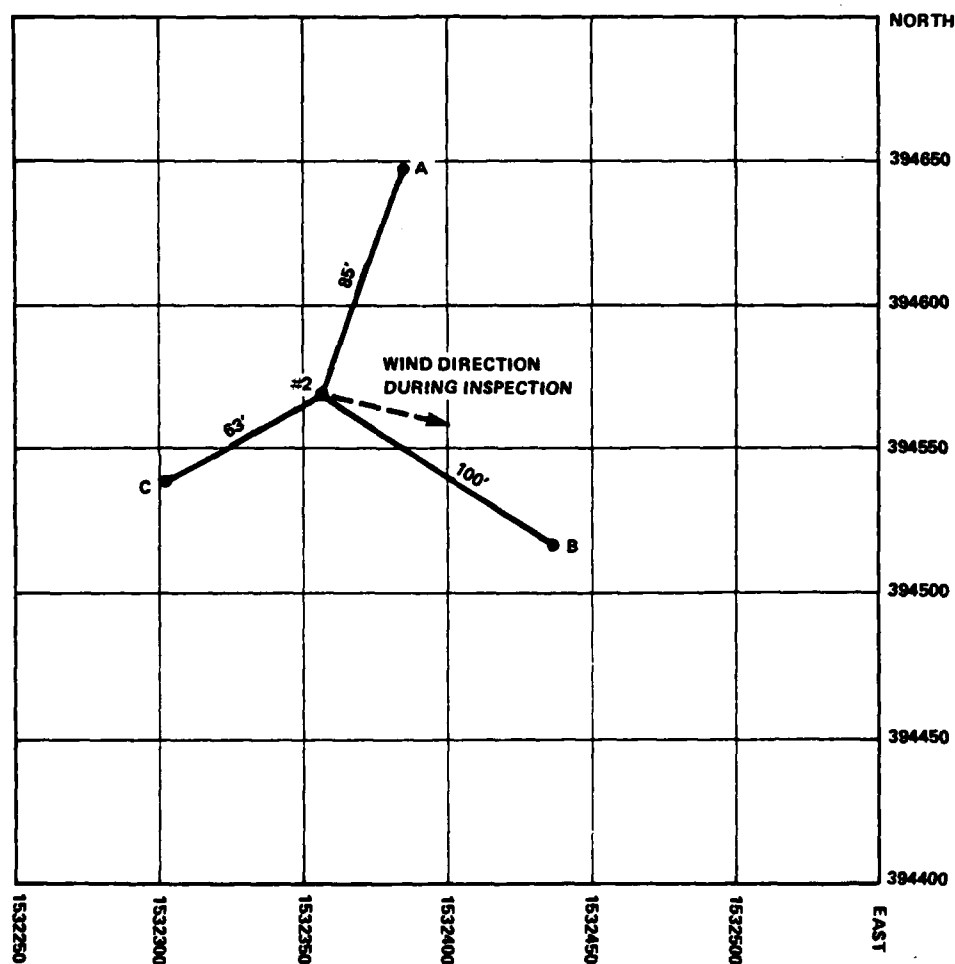
MOORING #2  
CONFIGURATION

The three ground legs, as initially installed, are comprised of 2 1/4" chain. Each of these legs enters the mud at a depth of about 90'. Double link measurements of each leg were taken just below the ground ring, at the wear point (mud line), and halfway in between the two. Measurements were all greater than 90 percent of original wire diameter. Measurements of the catenary angles at three depths of each leg were taken, and the results are noted on the following diver report sheet.

This mooring is in satisfactory condition for continued use in its currently rated capacity as a modified Class E mooring.

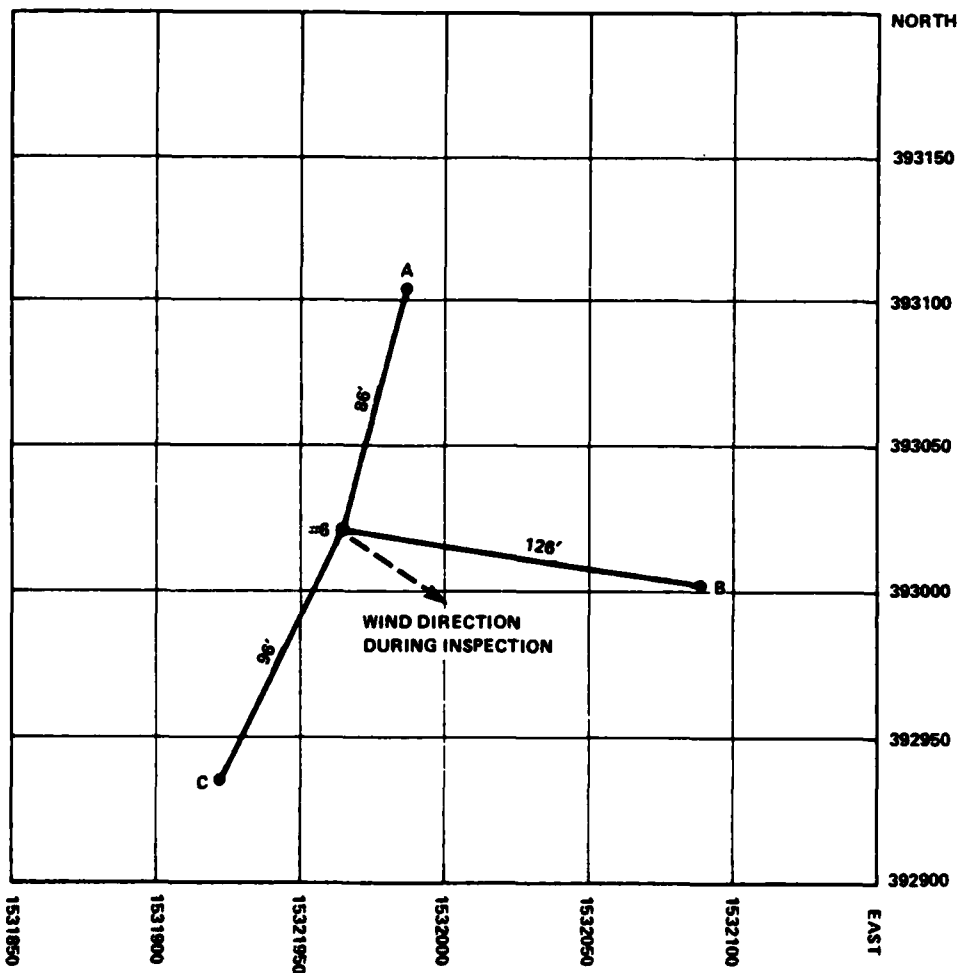
MOORING =6  
CONFIGURATION

The three ground legs, as initially installed, are comprised of 2 1/4" chain. Each of these legs enters the mud at a depth of about 85'. Double link measurements of each leg were taken just below the ground ring, at the wear point (mud line), and midway between the two. Measurements were all greater than 90 percent of original wire diameter. Measurements of the catenary angles at three depths of each leg were taken, and the results are noted on the following diver report sheet. Each leg has 5' - 10' of chain on the bottom before the leg becomes buried in the mud.

(2) DUE TO A FIRM MUD BOTTOM, EACH LEG HAS 6-10 FEET OF CHAIN ON THE BOTTOM PRIOR TO BEING BURIED. POP FLOAT MARKERS ON EACH LEG WERE TIED ABOUT 6' PRIOR TO LEG BOTTOM ENTRY.

This mooring is in satisfactory condition for continued use in its currently rated capacity as a modified Class E mooring.
